Assessment of Existing Coating System and Test Repainting System on Steel Bridge in Myanmar

Abstract: In Myanmar, corrosion problem of steel bridges due to coating deterioration are much severe. So corrosion protection techniques for repainting system is needed in Myanmar. This paper represents the existing coating deterioration on truss and after that test repainting systems of Min Chaung Bridge, Rakhine State, Myanmar. Min Chaung Bridge was chosen for test repainting system because Rakhine State is high atmospheric corrosivity category (C4). The aim of this study is to assess the preliminary assessment of the bridge truss coating for pilot repainting. It contains assessment for evaluation of measuring coating thickness, surface salinity and surface treatment method. The results of this investigation are that minimum coating thickness is less than MOC (Ministry of Construction) requirement and in some points; thicknesses are larger than 1.5 times - 2.5times. The existing coating thickness is in the range of 140 μ m - 720 μ m for all diagonals of truss. For test repainting system, after three months period data are compared. Almost all coating thickness data and gloss retention da

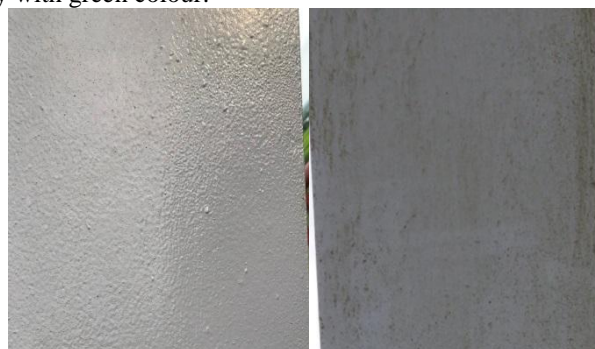
Figure 4. Photos of Health Condition on Existing Coating

The coating conditions of Min Chaung Bridge were conducted on September, 2018. It was constructed last 19 years ago. MOC tendered for repainting work in March, 2018. The configuration of the paint condition in bridge looks fine. In most of the surface of the vertical members have clear surface; however, diagonal members are relatively dirty with green colour.

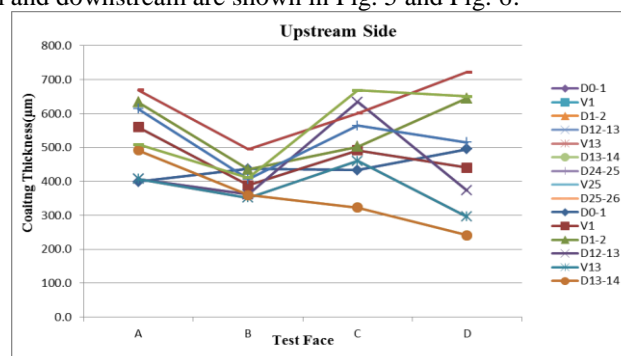
Figure 5. Coating thickness comparison for vertical and diagonal members (upstream side)

In these cases, the maximum coating thickness is 721 μm . The required thickness for MOC limitation of paint coating system for Min Chaung Bridge is 280 μm . It may be that repainting work system is over coating or without removing intermediate or top coat [3].

For upstream side, the minimum coating thickness is 241µm on face D of D13-14 and the maximum coating thickness is 721µm on face D of V25.

- By comparing the coating thickness for members, coating thickness on all faces is much different. On upstream side, flange coating thickness (Face D of D13-14) is less than 280µm and other members for Face D are more than 280µm-700µm.
- On downstream side, flange coating thickness (Face D of D1-2, D24-25, V25, and D25-26) is less than 280µm. Other members for Face D are within 280µm-700µm.

In this case, repainting system is over coated (without removing top coat or intermediate coat) over existing coating layer in maintenance operation so that coating thickness is over limitation (280µm). So that, right repainting procedure must be carried out or skill of the workers might be efficient and technical rules were followed when repainting in steel truss bridge. For improving the test repainting system, choose the best coating system on existing condition, surface treatment method, repainting procedure and environmental conditions are important.

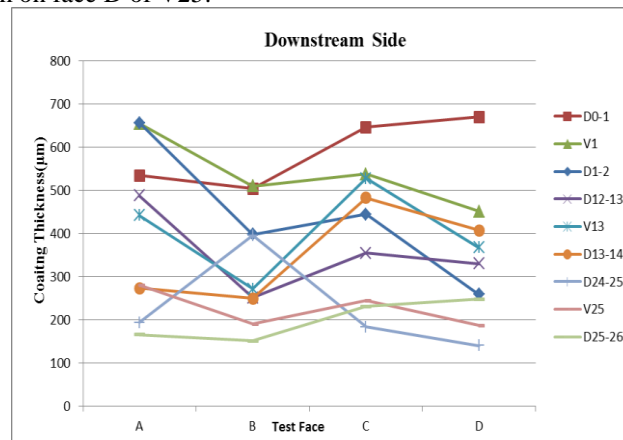
Figure 6. Coating thickness comparison for vertical and diagonal members (downstream side)

For downstream side, the minimum coating thickness is 140µm on face D of D24-25 and the maximum coating thickness is 670µm on face D of D0-1.

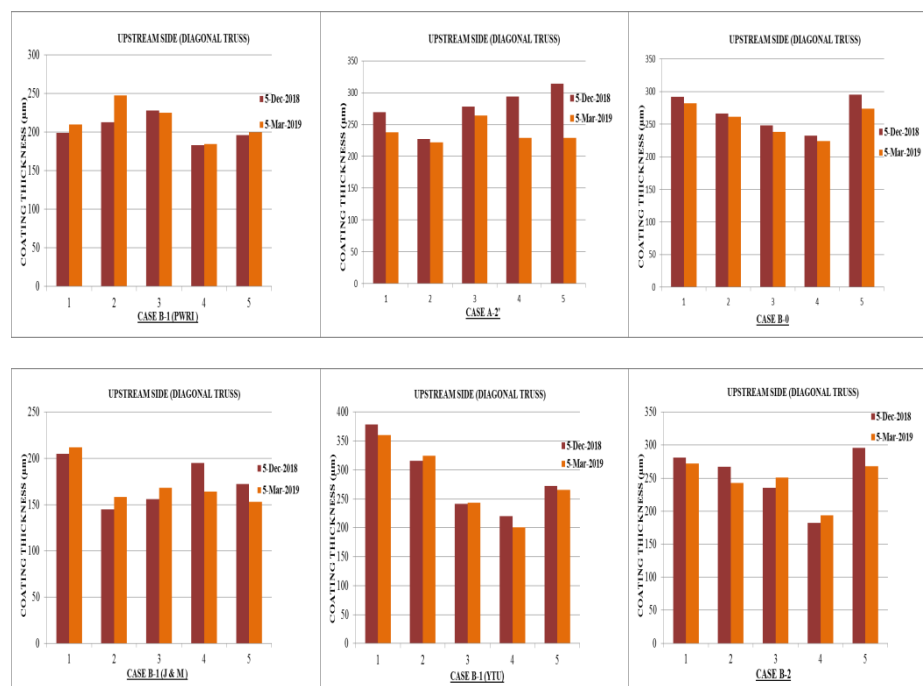
Figure 8. Comparison of coating thickness for Case A-2', Case B-0, Case B-1(PWRI) , Case B-1(J&M), Case B-1(YTU) and Case B-2

The evaluation of measuring coating thickness data normally decrease but for except in Case B-1 and Case B-2, some coating thickness data increase after repainting at 3 months period. This case may be that the amount of moisture content in atmosphere may be higher in these days.

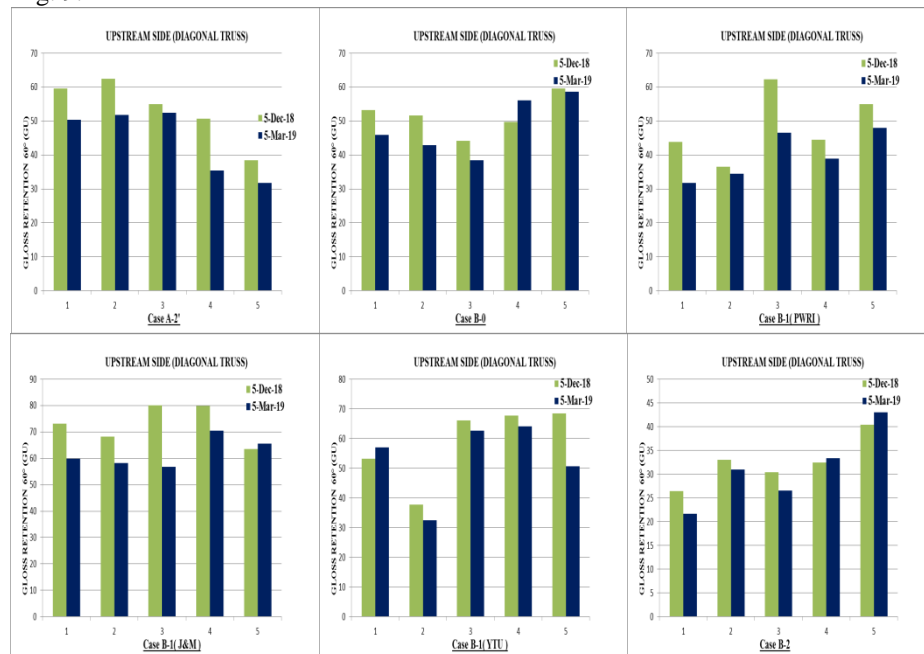
Figure 9. Comparison of gloss retention 60° for Case A-2', Case B-0, Case B-1(PWRI), Case B-1(J&M), Case B-1(YTU) and Case B-2

The results data for gloss retention (60°) of all cases also decrease for all Cases but some points in Case B-0, Case B-1 (J&M) and Case B-2 increase after 3 months period. The results data for gloss retention (20°) of all cases also decrease for all Cases but some points in Case B-1 (YTU) and Case B-2 increase after 3 months period. Gloss data decrease after 3 months period because the coating surface degrades.
